# Manhole Inspection Summary

Manhole # S45E2\_009MH

Insp Date: **12/31/07 10:24 AM**

**Location** Address: **1328 Tompkins St**

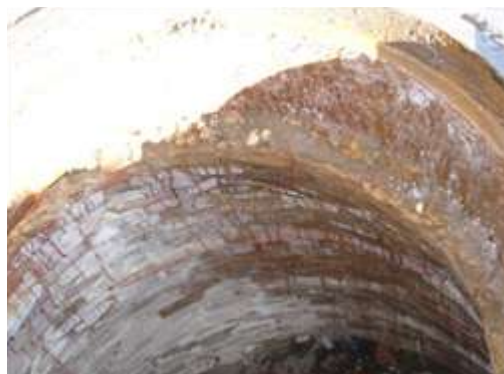
Defect 2

**Frame** Offset: **1** (in.) Condition: ☒ Sound ☐ Cracked ☐ Leaks

Frame offset

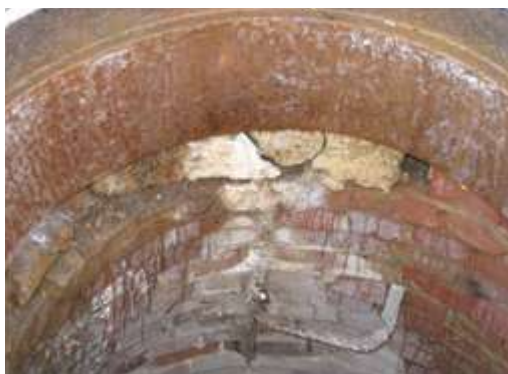
Defect 1

Condition: ☐ Sound ☐ Cracked ☐ Root Intrusion ☒ **Loose Brick** ☐ Deteriorated

Infiltration: ☐ None ☒ **Joint** ☐ Cracks ☒ **Mortar** ☐ Roots ☐ Wall

Loose bricks

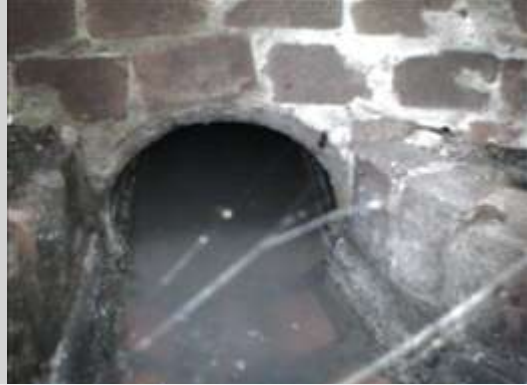
12 O'Clock Outflow

8 in. Circular Gravity Sewer  
Pipe Out @ 12 O'Clock

Pipe Height: **9.6** (in.) Rod and Bar (Angled)  
Pipe Material: **Clay** ☐ Pipe Lined  
Invert Depth: **7.11** (ft.) Flow Characteristics: **Fast**  
Deposits: ☒ None ☐ Mud ☐ Sludge ☐ Debris ☐ Grease  
Silt Depth: (in.) Deposits Extent:  
Infiltration: **None** Pipe Seal Cond: **Sound**

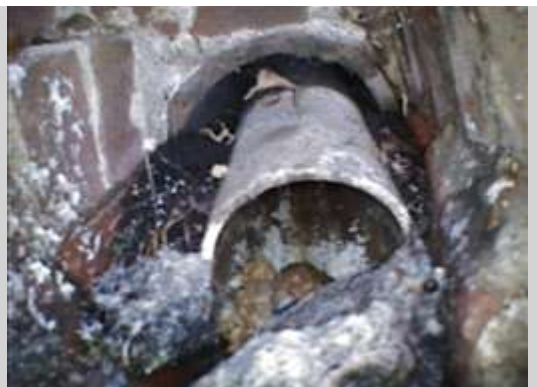
3 O'Clock Inflow

6 in. Circular Service Sewer  
Pipe In @ 3 O'Clock

Pipe Height: **3.6** (in.) Rod and Bar (Angled)  
Pipe Material: **PVC** ☐ Pipe Lined  
Invert Depth: **6.81** (ft.) Flow Characteristics: **None**  
Deposits: ☐ None ☐ Mud ☐ Sludge ☒ **Debris** ☐ Grease  
Silt Depth: **0** (in.) Deposits Extent: **Medium**  
Infiltration: **None** Pipe Seal Cond: **Sound**

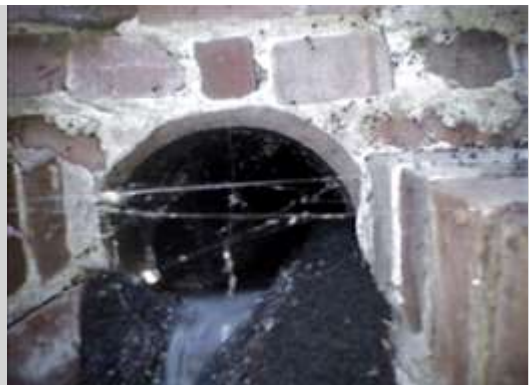
6 O'Clock Inflow

8 in. Circular Gravity Sewer  
Pipe In @ 6 O'Clock

Pipe Height: **8.4** (in.) Rod and Bar (Angled)

Pipe Material: **Clay** ☐ Pipe Lined

Invert Depth: **6.44** (ft.) Flow Characteristics: **Fast**

Deposits: ☒ None ☐ Mud ☐ Sludge ☐ Debris ☐ Grease

Infiltration: **None** Pipe Seal Cond: **Sound**
